CENTRAL INTELLIGENCE AGENCY

INFORMATION REPORT

COUNTRY	Czechoslovakia	REPORT			
SUBJECT	Prerov Military Airfield	DATE DISTR.	17 January 1955		
Γ		NO. OF PAGES	11 25X1		
DATE OF INFO.		REQUIREMENT NO.	₹ D		
PLACE ACQUIRED		REFERENCES	25 X 1		
	USAF review completed.				
	THE APPRAISAL OF CONTENT IS T	FNTATIVE			
	THE APPRAISAL OF CONTENT IS 1 (FOR KEY SEE REVERSE)

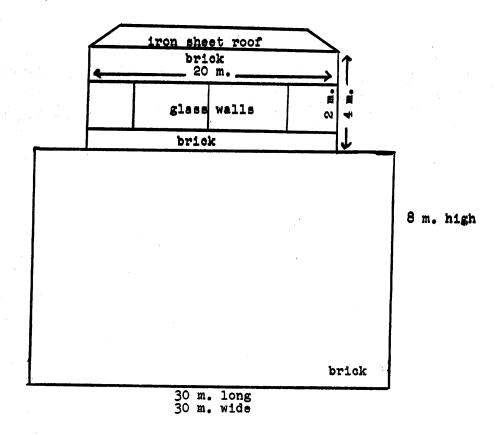
Control Tower at Prerov Airfield

Control tower. Built about 1950. (See page 8 of this report.)

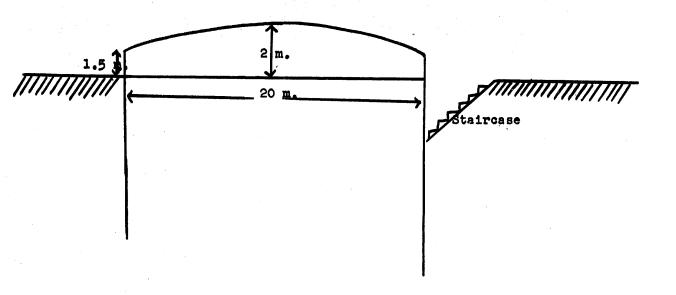
Underground Ammo Storage at Prerov Airfield

26.	Ammunition storage.	
. [There were three round reinforced concrete construction protruding about two meters above the ground. (See page 9 of this report.) Airmen referred to it as "Vrchlik".	ns 2

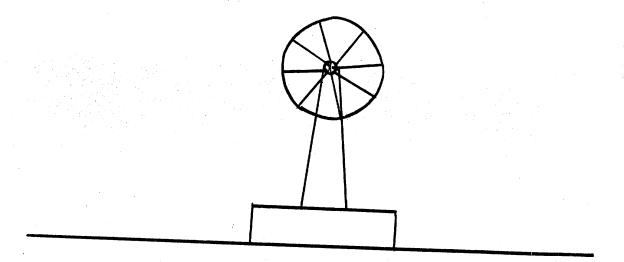
Radar at Prerov Airfield

comment twice	saw a stee struction on the circular stand with a rotating object on top. In the SVAZARN it was a mon rumor that it was a radar installation. Saw it rotate in July 1954. (Refer to page 10 of this report, a sket the radar installation.) Aircraft capacity in September 1953 was about 12 place MIG-15's, 17 single-seat MIG-15's.	1 2 e ch ₂
